Finish Defects During Production

Finish Defect #4: Fat edge occurring during spray operations

By Bruce Jackson

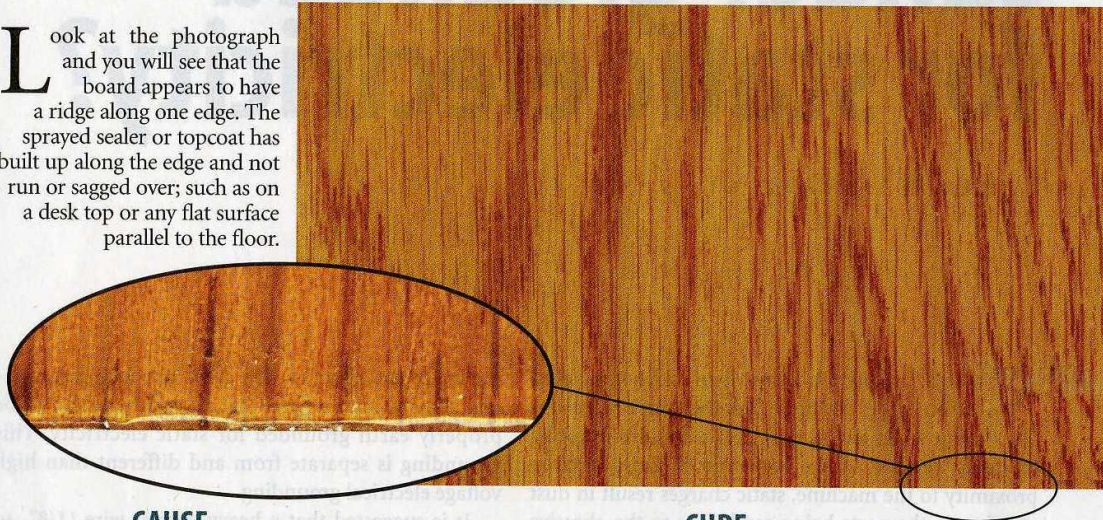
Look at the photograph and you will see that the board appears to have a ridge along one edge. The sprayed sealer or topcoat has built up along the edge and not run or sagged over; such as on a desk top or any flat surface parallel to the floor.

Gun is tilted at an angle and pushing material towards item edge. This would be similar to shoveling snow or using a push broom to sweep dirt; you end up with a pile of snow or dirt. In finishing you end up with a pile of sealer or topcoat.	Gun must be perpendicular to surface and not "pushing" material towards edge.
Viscosity is incorrect. The material is too thick.	Thin material to manufacturers recommended viscosity.
Too much fluid	Check adjustment of fluid delivery rate. Check if fluid tip is worn. Check size of tip orifice to material viscosity.
Temperature	Warm chilled or cold part.
Solvent mix	Have supplier check blend of solvents with possibility of introducing faster evaporating solvents.
